Rhoden Roofing, LLC

RoofCare Audit

Inspection report for [Property Address]
Conducted by [Tech Name] on [Date]

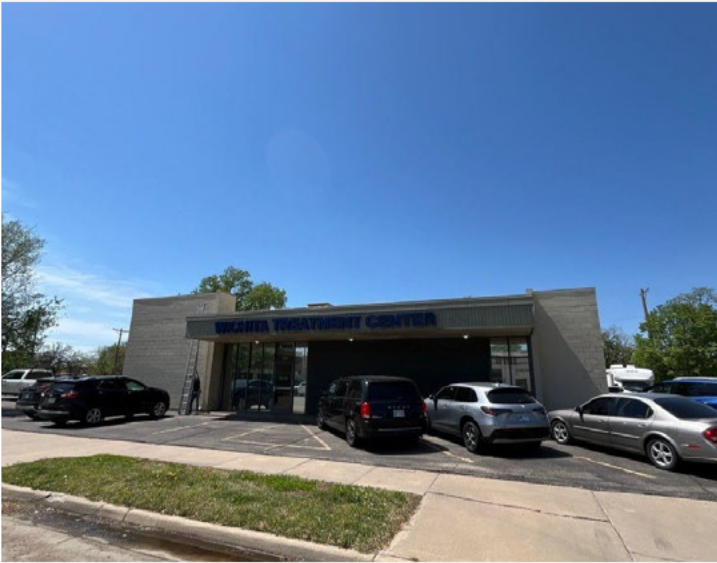
1

Front of the building.

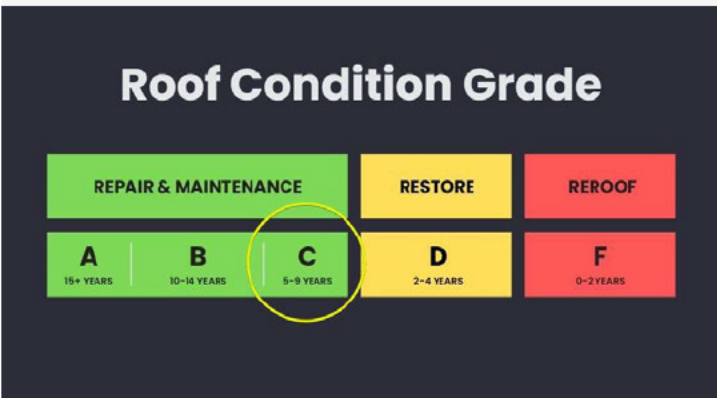
2

This roof is within the Repair & Maintenance range. With continued maintenance, its service life can be preserved for approximately five more years.

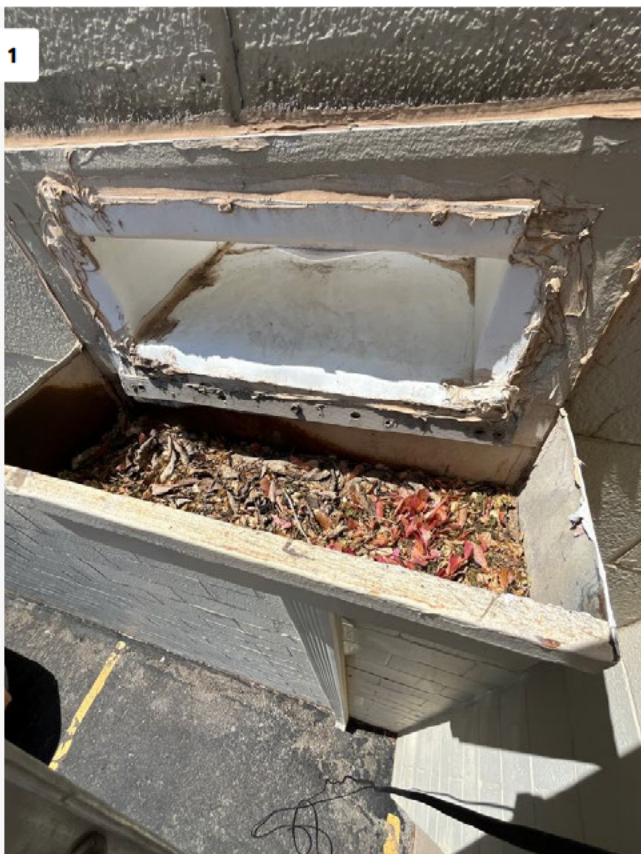
1

Collector head is full of debris, preventing water from draining through the external drainage system.

- **Scope of Work for Repair:** Inspect, clean, and re-weld any bad/cold welds in TPO membrane | Install up to 15 new T-Joint Patches as needed | Remove 6 concrete blocks from the roof system | Seal termination bar on HVAC units as needed | Clean up and haul off all debris, including debris corking collector heads and affecting drainage on the field of the roof | Obtain permit and include, if required.
- Estimate for Needed Repairs: **\$3,258.37**

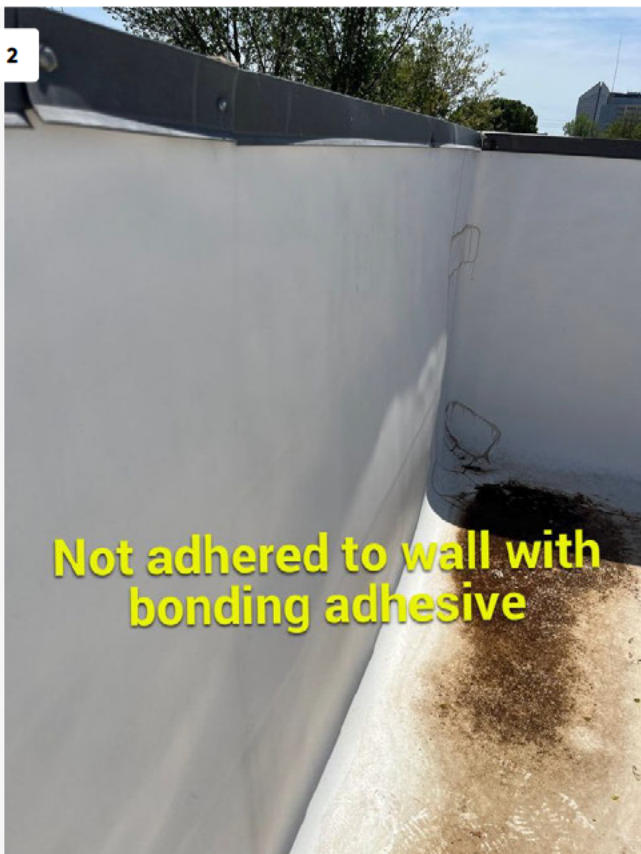
2

Membrane on perimeter wall is not fully adhered to the wall, which makes it vulnerable to wind uplift and damage. Does not comply with manufacturer's spec.

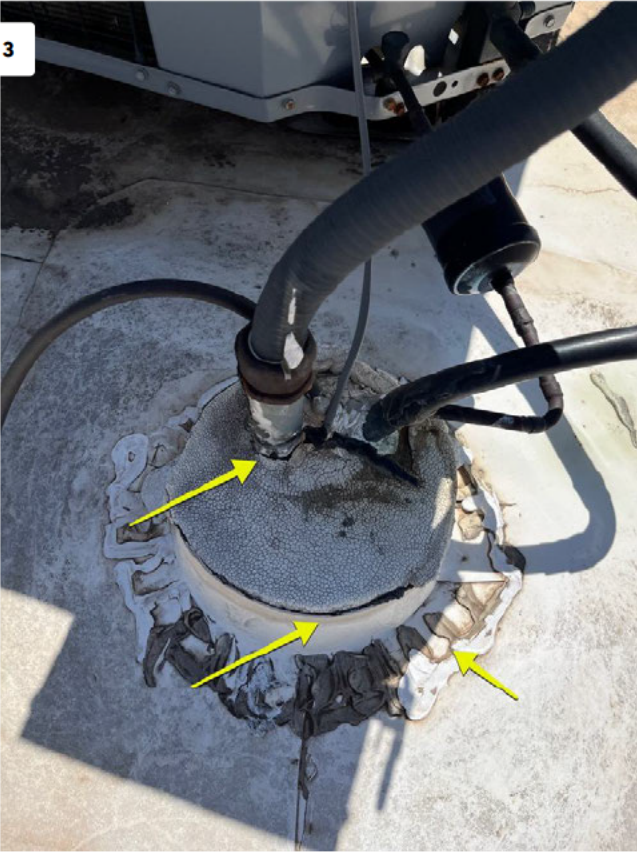
3

Pitch pocket improperly installed. Primer was not used at installation, resulting in sealant failure. Previous repair attempts treated field membrane, which was not solvent.

Short-Term Repairs: Seam tune-up for all identified cold welds and failed seams Re-flashing of penetrations as needed. Continued monitoring of parapet flashing and overall system during ongoing Roof Care inspections is recommended.
